DOC# 0384

By Mike Josiah and the Technical Staff at Summit Technologies

HP LJ M5025 / M5035 TONER CARTRIDGE REMANUFACTURING INSTRUCTIONS

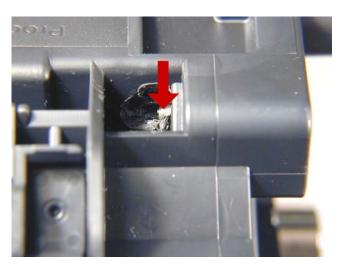
Figure 11

2) To remove the pins, 2 small holes must be cut. Cut the holes with the Dremmel tool, and a side cutting bit. See Figures 9, 10, 11, 12, & 13

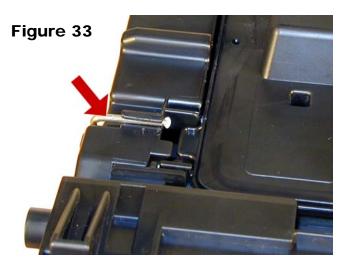
Figure 32

- 15) Place the waste chamber aside.
- 16) Remove the drum cover by prying the spring loaded arm, and then carefully pry off the two metal bars out of their holders. The cover must be in the closed position in order to pry off the spring loaded arm. Be careful not to loose the spring! Both of the metal bars should be removed from the front not the end. See **Figures 31, 32, & 33**

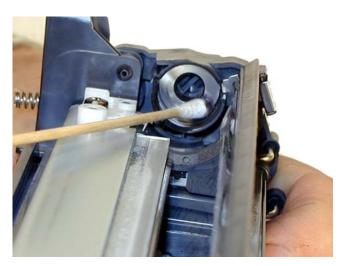
Figure 44

- 23) Clean out any remaining toner.
- Figure 41
- 24) There is no fill hole in these cartridges so it must be filled through the DB slot. Fill the cartridge with 715g (Preliminary weight) of M5025 toner. See **Figure 42**
- 25) If a seal is available, install it now.
- 26) Make sure the doctor blade seals are clean. Install the doctor blade and 2 screws. See **Figures 43 & 44**
- 27) Clean the mag roller contact plate on the end cap that is still on the cartridge. Replace the conductive grease. See **Figure 45**

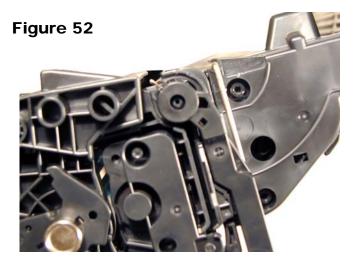
32) Install the spring in the drum cover arm as shown. Install the metal bar into the hole and slot. Install the arm. See **Figures 51 & 52**

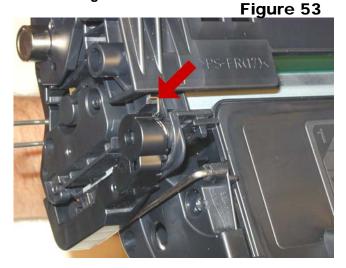
33) Release the tail of the spring so that the cover closes. See **Figure 53**
