## Samsung ML-1210 / Lexmark E-210 Toner Cartridges

DOC-0288

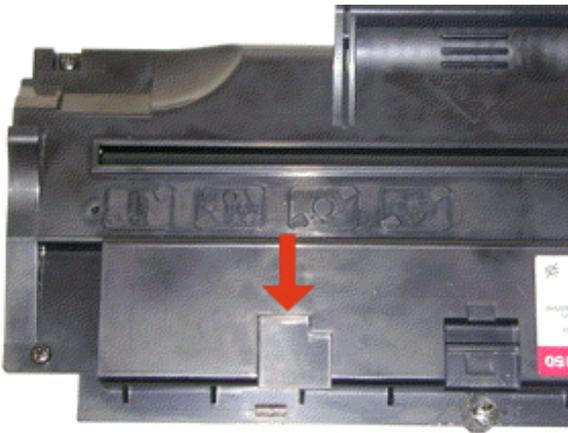
FIGURE 1

The various models listed all use the same supplies to recycle, however we cannot confirm that they are all interchangeable. The Samsung versions have proved very difficult to find. See Figure 1 for the Lexmark Version. The cartridge is an All in one type cartridge, (it houses the toner supply, OPC drum, and waste chamber). The standard cartridge comes new with 65g toner, and is rated for 2,500 pages at 5% coverage.

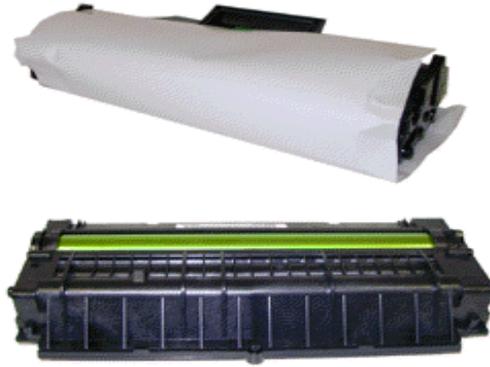
FIGURE 2

These cartridges are unique in a number of different ways, the first is that they do not have a drum cover, and come new with a piece of heavy paper taped around the cartridge. (See Figure 2) Second is that they do not use a seal. (All new cartridges opened so far have shown some toner leakage that would have shown on any prints). Lastly there is a screw on the top center that is a "One Way" Security type screw. This screw calls for a special driver to remove it, unfortunately these screws seem to be a specialty item made for Lexmark. It can also be done with wire cutters, not as neatly, but not that hard to do either. This will be gone over later in the procedure.

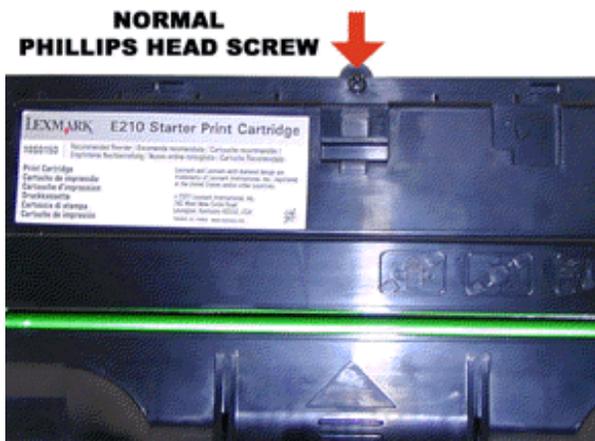
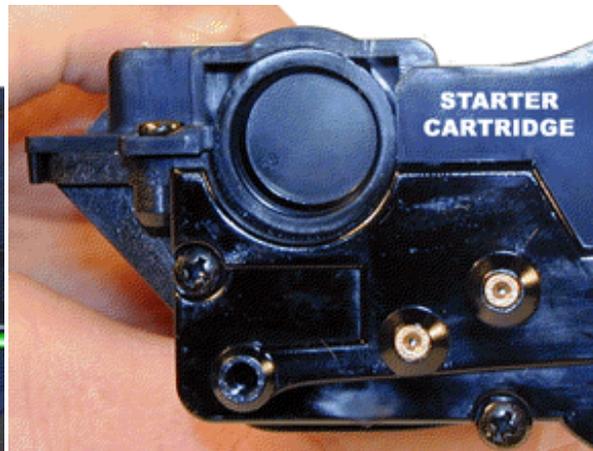
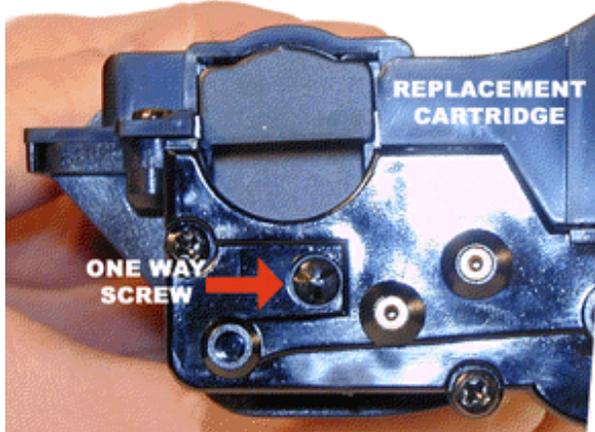
The Starter cartridge that comes with the Printer has two major differences from the replacement cartridge. 1) These cartridges do not use a "One Way" security screw, and 2) they have a fill plug. The replacement cartridge has a plastic wall in place of the fill plug that is held in place by another "One way" screw. Clearly the replacement cartridges were designed to annoy Re-manufacturers. See Figures 3, 4, and 5.

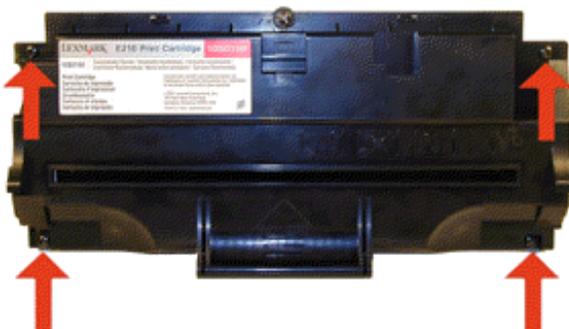
FIGURE 6

1. Place the cartridge with the handle facing up. Remove the 4 top corner screws. See Figure 6
2. Also on top of the cartridge in the center, is the security screw. We are continuing to try and source the driver bit for these screws. We have contacted numerous companies that specialize in security screws; no one has ever seen a screw like this! At this time it is safe to say that a driver for these screws is not available. Lexmark Strikes again! The best way to remove the screw at this time is to take the pair of flush cutting wire cutters, and cut the plastic ring around the screw away. Grab the screw with the cutters, twist and remove. Not a pretty solution, but effective. We are continuing to look for a driver and will send out a news release when we find them. See Figure's 7 & 8

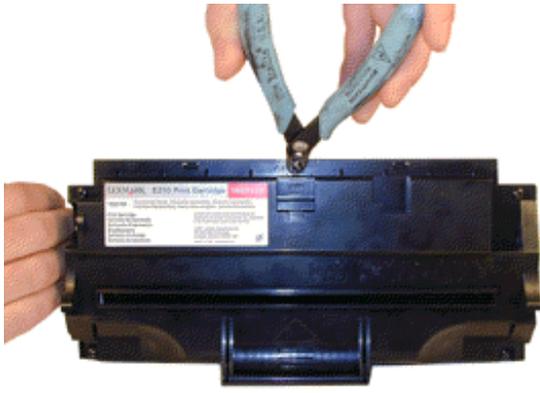
FIGURE 8

The screw looks like it takes a "Tri-Wing", or "Tri-Groove" tool, it doesn't. It is actually almost a REVERSE combination of the two. Instead of being recessed, it is raised, with small recesses on top.

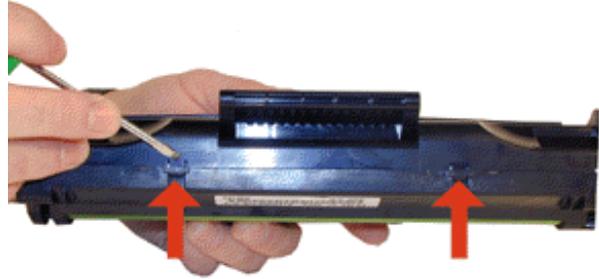
FIGURE 9

3. Underneath the handle of the cartridge, there are 2 plastic tabs GENTLY press them in, and pry the cover off. See Figure 9

**CAUTION:** The upper half of the toner hopper is being removed. If there is a lot of toner left in the hopper, it can dump out all over! Vacuum the hopper clean.

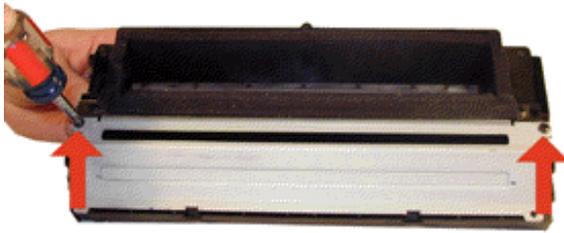
FIGURE 10

4. Remove the two screws on the metal brace, and the brace. See Figure 10
5. With the toner hopper facing away from you, remove the three screws on the right side end cap. Remove the end cap. See Figure 11 & 12
6. Also on the right side there is a series of gears under the end cap. Make a note of the location of each gear. If you are careful, it is not necessary to remove them. See Figure 13

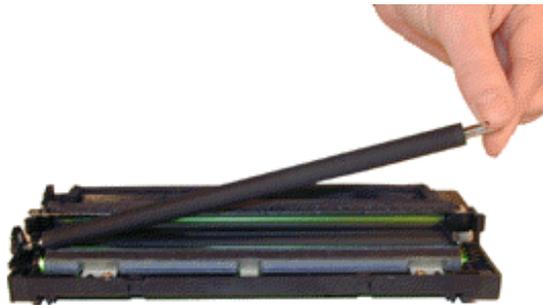
**FIGURE 14**

7. Remove the PCR. Figure 14
8. Clean the PCR with your normal PCR cleaner.

**WARNING:** Do not clean the OEM PCR with alcohol, as this will remove the conductive coating on the roller. IF the PCR is an after market, follow the cleaning methods recommended by the manufacturer. If the PCR is an OEM, we recommended it be cleaned with your standard PCR cleaner

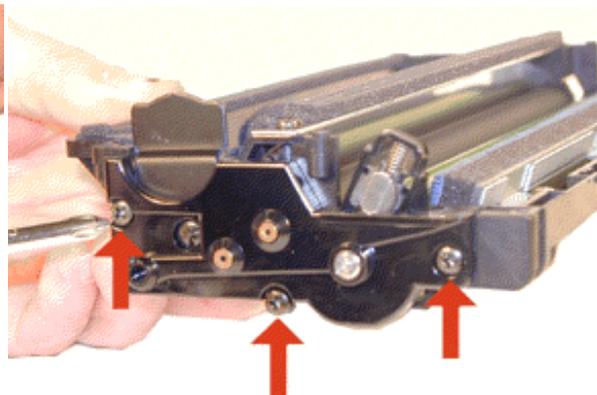
**FIGURE 15**

9. With the toner hopper away from you, remove the three screws on the left side end cap. Remove the end cap. See Figure 15
10. There are 2 screws on the Wiper Blade/PCR cleaner Assy. Remove them and gently pry the blade up. Be very careful not to break off the alignment tabs. We have found it best to lift up from both sides when removing this blade. See Figures 16 & 17

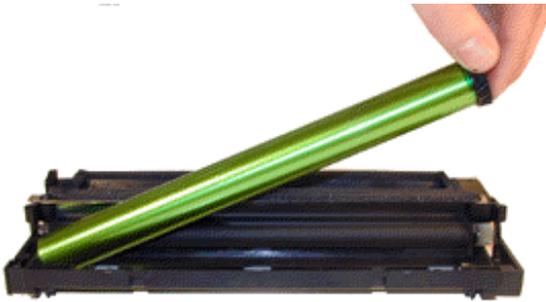
FIGURE 18

11. With the Wiper Blade removed the drum can easily be removed by lifting it out. See Figure 18
12. Clean out any remaining toner from the cartridge.
13. Remove all the Gears from the right side. See Figure 19
14. Press in on the top tab of the roller plate to release it. See Figure 20
15. Press in on the bottom tab of the roller plate to release it. See Figure 21

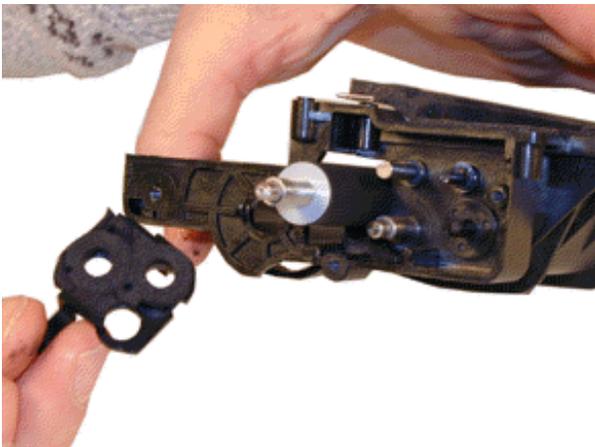
FIGURE 22

16. Gently pry out the roller plate from the cartridge. See Figure 22
17. Remove the Developer Roller. Be careful not to lose the spring on the opposite side of the roller.

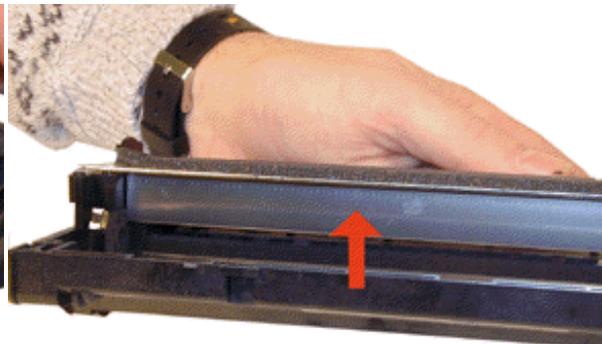
FIGURE 23

18. It is highly recommended that the Doctor Blade be cleaned. Failure to do so will cause streaking. The Doctor Blade can be cleaned with out removing it. Dampen a cotton swab with alcohol, and clean the blade. Be careful not to press too hard and damage the blade. If the blade has a heavy buildup of toner on it, clean it with Acetone, and then alcohol. Removing the blade is difficult because of the foam seals attached. If the seals are torn, the cartridge will leak. That is why we do not recommend it. Once replacement Dr. Blades are available, they will have to come with replacement foam. See Figure 23

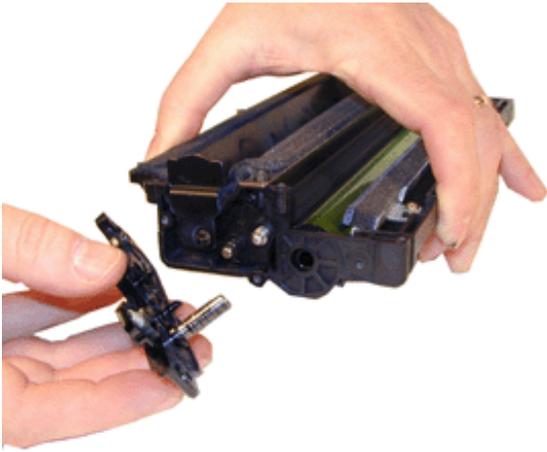
FIGURE 24

20. Replace the spring on the opposite side of the cartridge. See Figure 24
21. Install the cleaned wiper Blade/PCR cleaner Assy. and two brass colored screws. See Figure 25

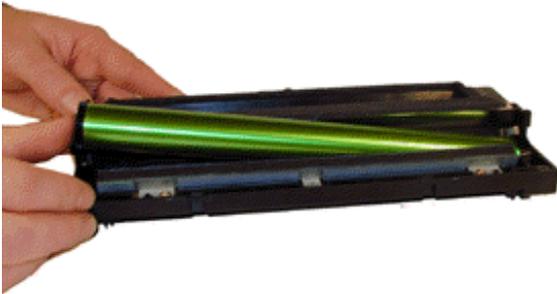
FIGURE 26

22. Install the drum back in place. See Figure 26
23. Replace the left side end cap and three screws. See Figure 27
24. Install the PCR. See Figure 28
25. Install the right side end cap and screws. Make sure the PCR fits correctly in its holder. See Figure 29

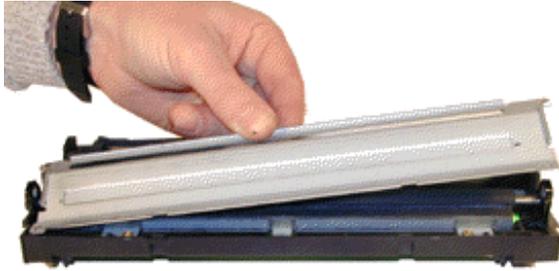
FIGURE 30

26. Replace the metal brace and two screws. See Figure 30

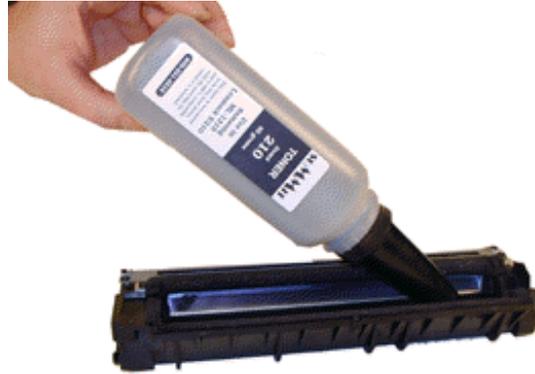
FIGURE 31

27. Fill the hopper with 65g of the 210 toner. See Figure 31
28. Carefully snap the cover on making sure all the tabs lock in place. See Figure 32
29. Install the five screws in the top cover. It is not recommended that the security screw be reused, unless you have the driver. Normal Canon screws work fine.

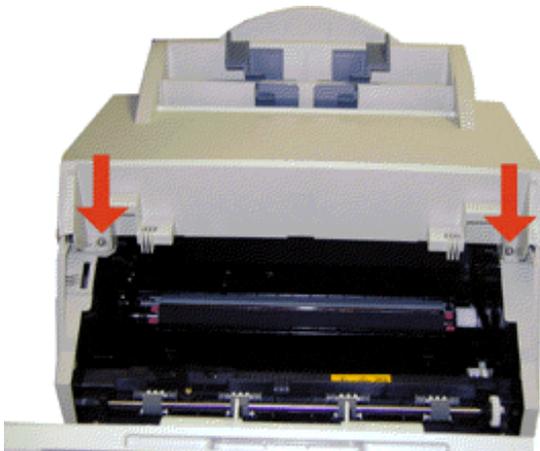
FIGURE 33

1. Remove the two top silver screws. The top cover will come loose. Lift up and remove the top cover. See Figure 33
2. Remove the three black screws from the laser unit. Carefully flip up the laser unit so that the metal tab is exposed. See Figure 34

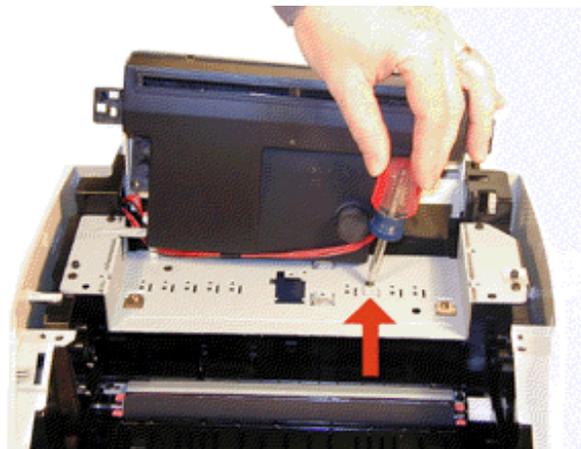
FIGURE 35

3. Remove the tab screw and tab. See Figures 35 and 36.
