Goldstar GL-660 Toner Cartridges

DOC-0284

REMANUFACTURING THE TONER CARTRIDGE

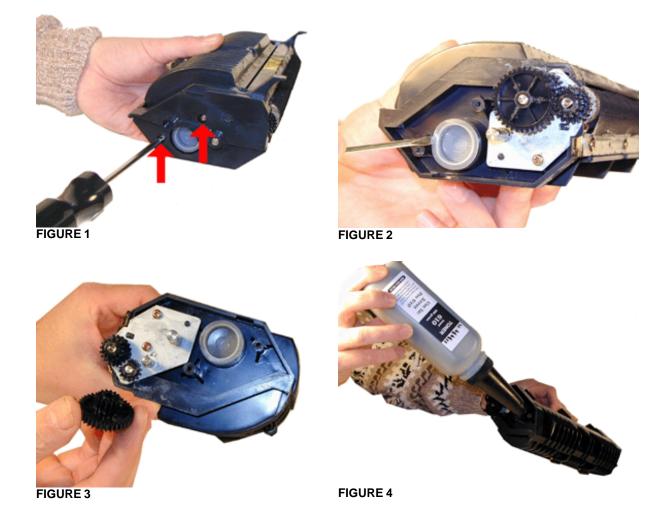
- 1. Remove the two screws from the right side end cap, remove the end cap. See Figure 1
- 2. Remove the fill plug and fill with 220g 610 toner. DO NOT clean the cartridge out as it also contains developer! Just add the new toner and reinstall the fill plug. Check the gears and shafts to make sure the grease is clean. If not, clean it off and replace with fresh white lithium grease. See Figures 2, 3 & 4.

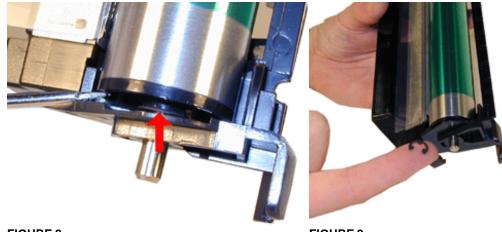
- 1. With the waste chamber facing you, look at the drum axle on the right side of the cartridge, but inside the plastic wall. There is an E-Ring locking the drum and shaft in place. See Figure 8.
- 2. Take two small common screwdrivers and press the E-Ring off the shaft. Take a spring hook and remove the E-Ring. See Figure 9
- 3. Slide the drum axle out from the right side, and remove the drum. See Figure's 10 & 11

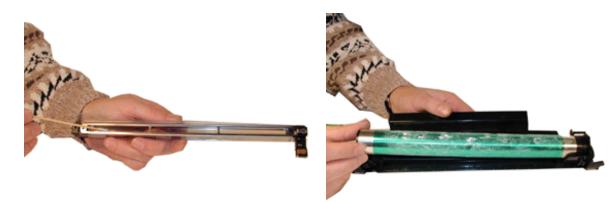
- 6. With a small screwdriver, fluff up the felts on both sides of the cartridge. See Figure 13. This will help prevent the toner from leaking around the edges of the drum.
- 7. With a cotton swab dipped in alcohol, clean the Primary Corona Wire. Clean the Grid also. Be careful not to leave any cotton threads on the Grid as they will cause the cartridge to leave dark black streaks. See Figure 14
- 8. Coat the drum with padding powder, and re-install in the cartridge. See Figure 15

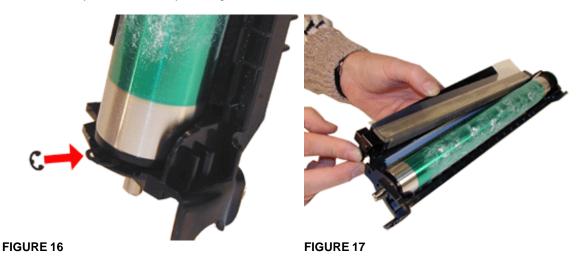
- 9. Slide the drum axle in, and snap the E-Ring back on the shaft INSIDE the plastic wall. Slide the E-Ring down the side of the wall, and press down with a small screwdriver. See Figure 16
- 10. Install the Primary Corona Wire Assy. See Figure 17
