CANON® IMAGERUNNER C3200

TONER CARTRIDGE REMANUFACTURING INSTRUCTIONS

REMANUFACTURING THE CANON IMAGERUNNER C3200 SERIES TONER CARTRIDGE

By Mike Josiah and the Technical Staff at UniNet

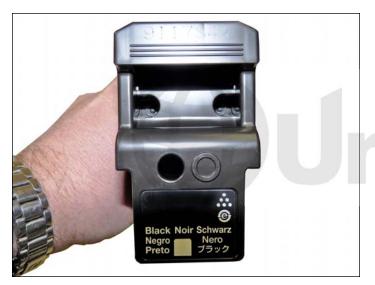
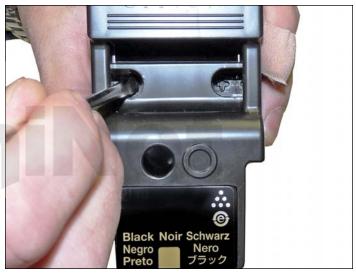
1. Take a long common (flat) screwdriver and insert it into the top two holes on the label end cap. Place the edge of the screwdriver against the plastic weld and snap the weld off in both places. This may have to be done multiple times from different angles.

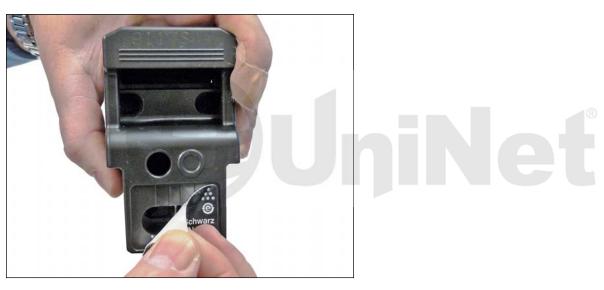
2. Remove the Cartridge ID label from the end cap.

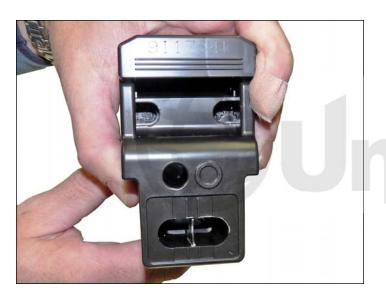
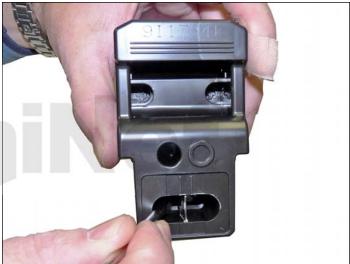
3. Remove the two remaining welds in the same manner as Step 1.

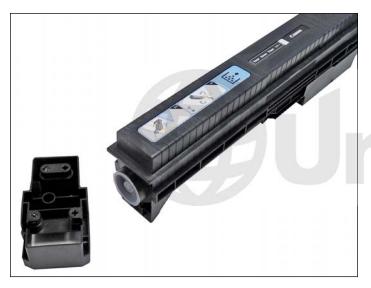
4. Remove the end cap.

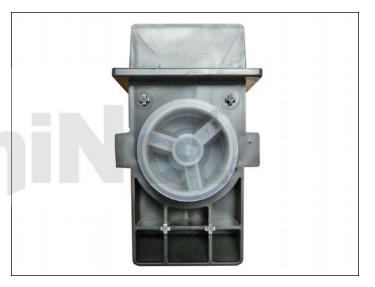
5. Remove the fill plug and clean out all remaining toner.

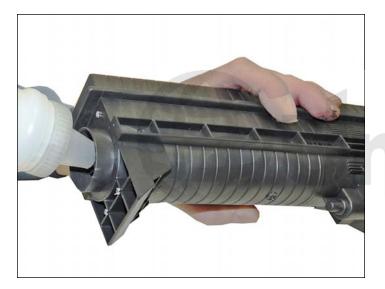
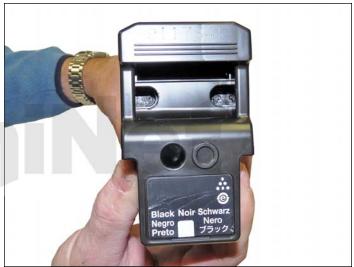
7. Install the end cap on the cartridge. An easy way to do this is to place four drops of hot glue on the four broken posts. Quickly place the end cap on before the glue dries. If further help is necessary to keep the end cap on, black tape along the seam works well.

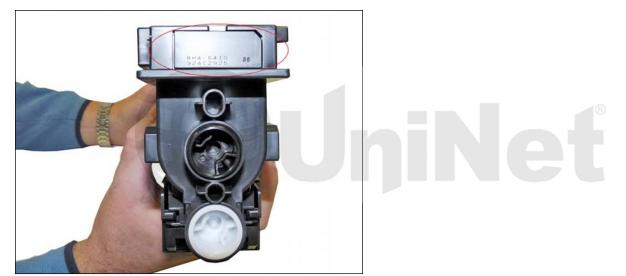
8. Replace the chip from the opposite end of the cartridge. This chip is an RF type that is encased in the same type plastic housing as the HP 4100 chips are. The chip is different though!
